Notes on Rebuilding the Wurlitzer Unit Valve

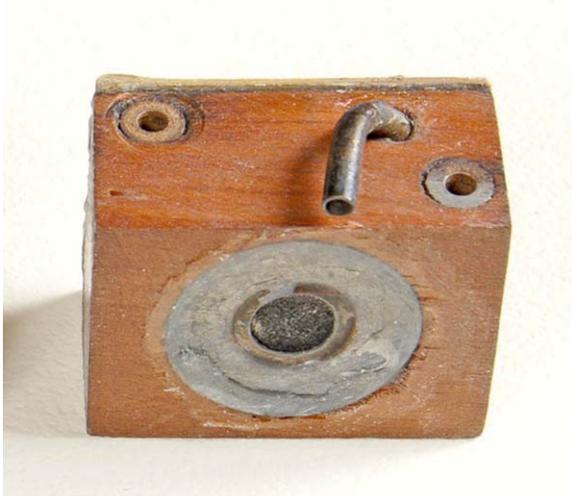
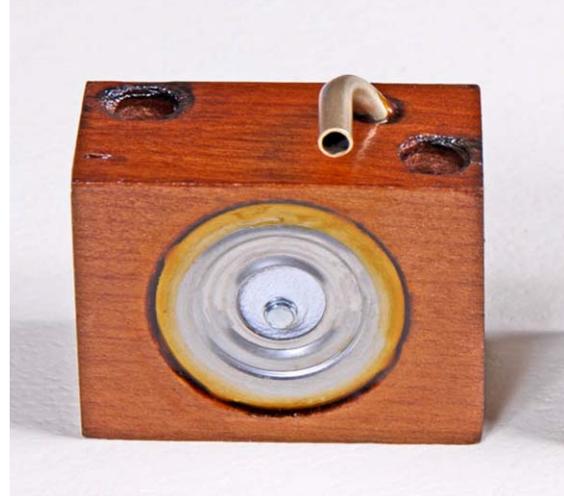
Ron Yost recently became the proud owner of an original Wurlitzer 105 and is now in the process of rebuilding it. Along the way, Ron loaned me three of his original unit valves so that I could add to my collection of pictures and measurements of all things Wurlitzer 105, and maybe do some documentation on the process of rebuilding the Wurlitzer Valve. On the left above is one of the original valves and next to it is the same valve after rebuilding. For some reason the original springs holding in the valves were removed and the recess for the spring was filled with a wood plug. Ron and I speculate that the recess was filled to allow the same screws to be used without driving the screws all the way into the air passages of the Stack. These plugs were drilled out with a 5/16" Forestner drill.

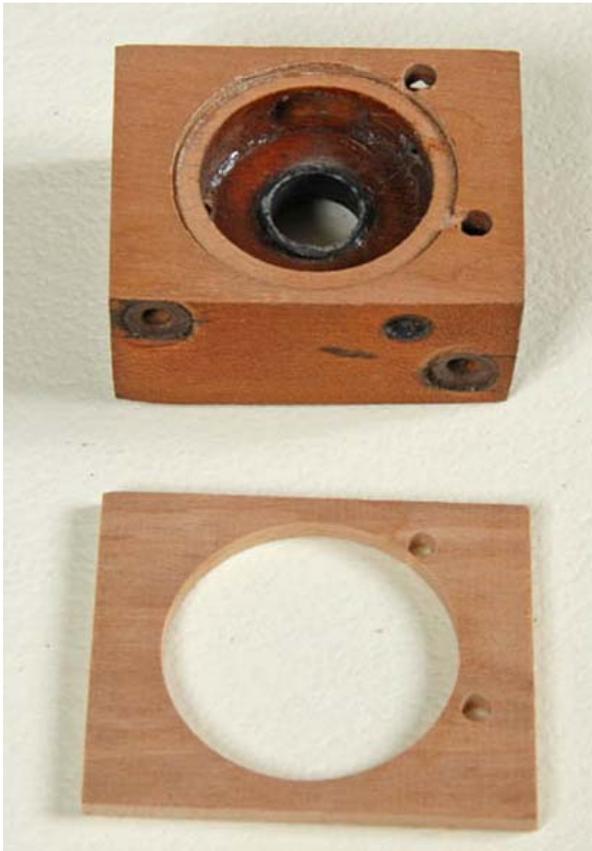
Several pieces of 1/8" thick mahogany were drilled using a 1-3/8" diameter Forestry bit, the same as the Pouch Well, just in case Ron comes across more valves that have to be laminated.

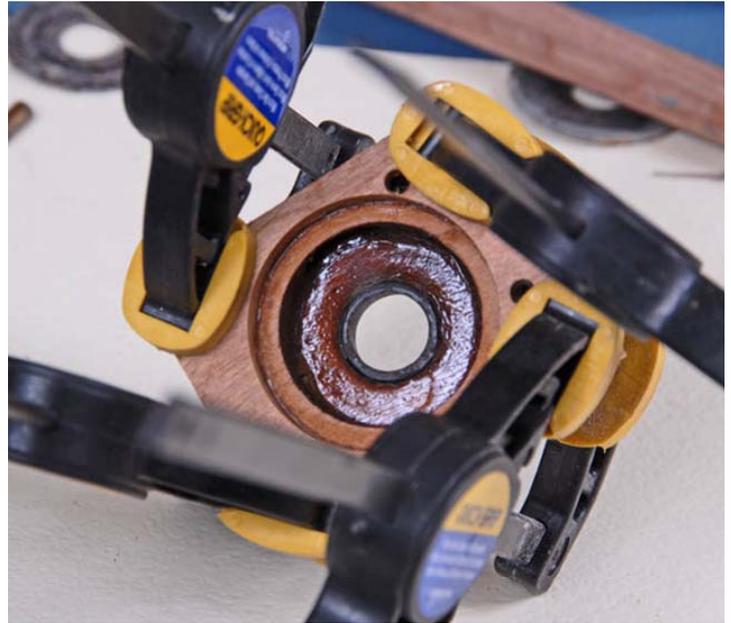
The upper valve seats had to be replaced in most cases. Because the adjustment capability was removed when the valves were last rebuilt, it appears that valve travel was adjusted in some cases by flattening the "dish" in the upper seat to increase travel. In cases where this was done, it damaged the seat beyond repair. With few exceptions, once the block was cleaned up and sealed, the rebuild followed the process used for building a new valve that is covered in the *Notes for Making the Wurlitzer Unit Valve* PDF. The one exception is the size and length of the fluted stem.

The hole in the original lower seat measures .425" so the diameter of the fluted stem was made about 95% of that or .400". Because of small changes that might have been made in previous rebuilds or in cases where the pouch well had to be drilled slightly deeper, the length of the fluted stem had to be checked in every case to make sure that the stem provided for the required 1/16" lost motion to account for any future pouch shrinkage that might otherwise pull the valve off the lower seat.

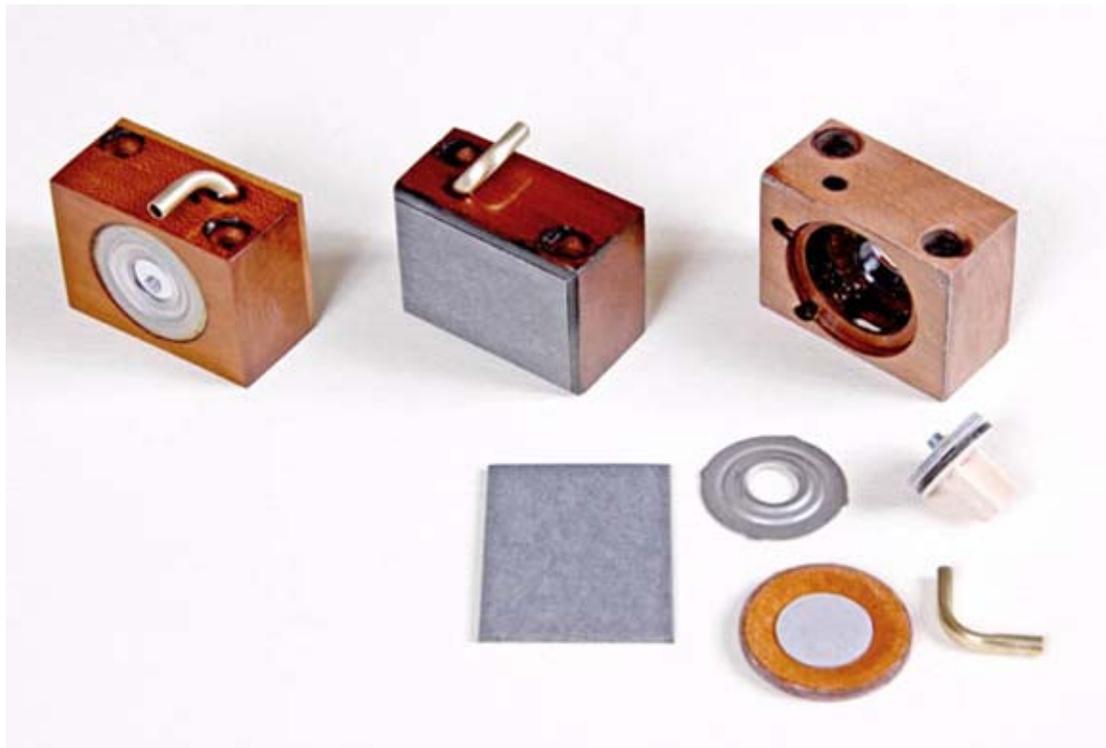
After valve travel was adjusted and the upper seat was sealed with burnt shellac, the Upper Seat hole was covered with a round punching of masking tape and the valves were sprayed with two coats of clear shellac. The cleaned-up original elbows were reinstalled and sealed with burnt shellac.

The valves improved in performance noticeably after the final step of spraying them with shellac. Sealing, inside and out is always very important, but since the original wood seems to be very porous, and quickly soaked up the first coat of shellac, the sealing of these original valve blocks, is particularly important.
